AFML-TR-79-4209

FATIGUE CRACK PROPAGATION AND CORROSION
FATIGUE OF AF 1410 STEEL

S. D. ANTOLOVICH

JANUARY 1980

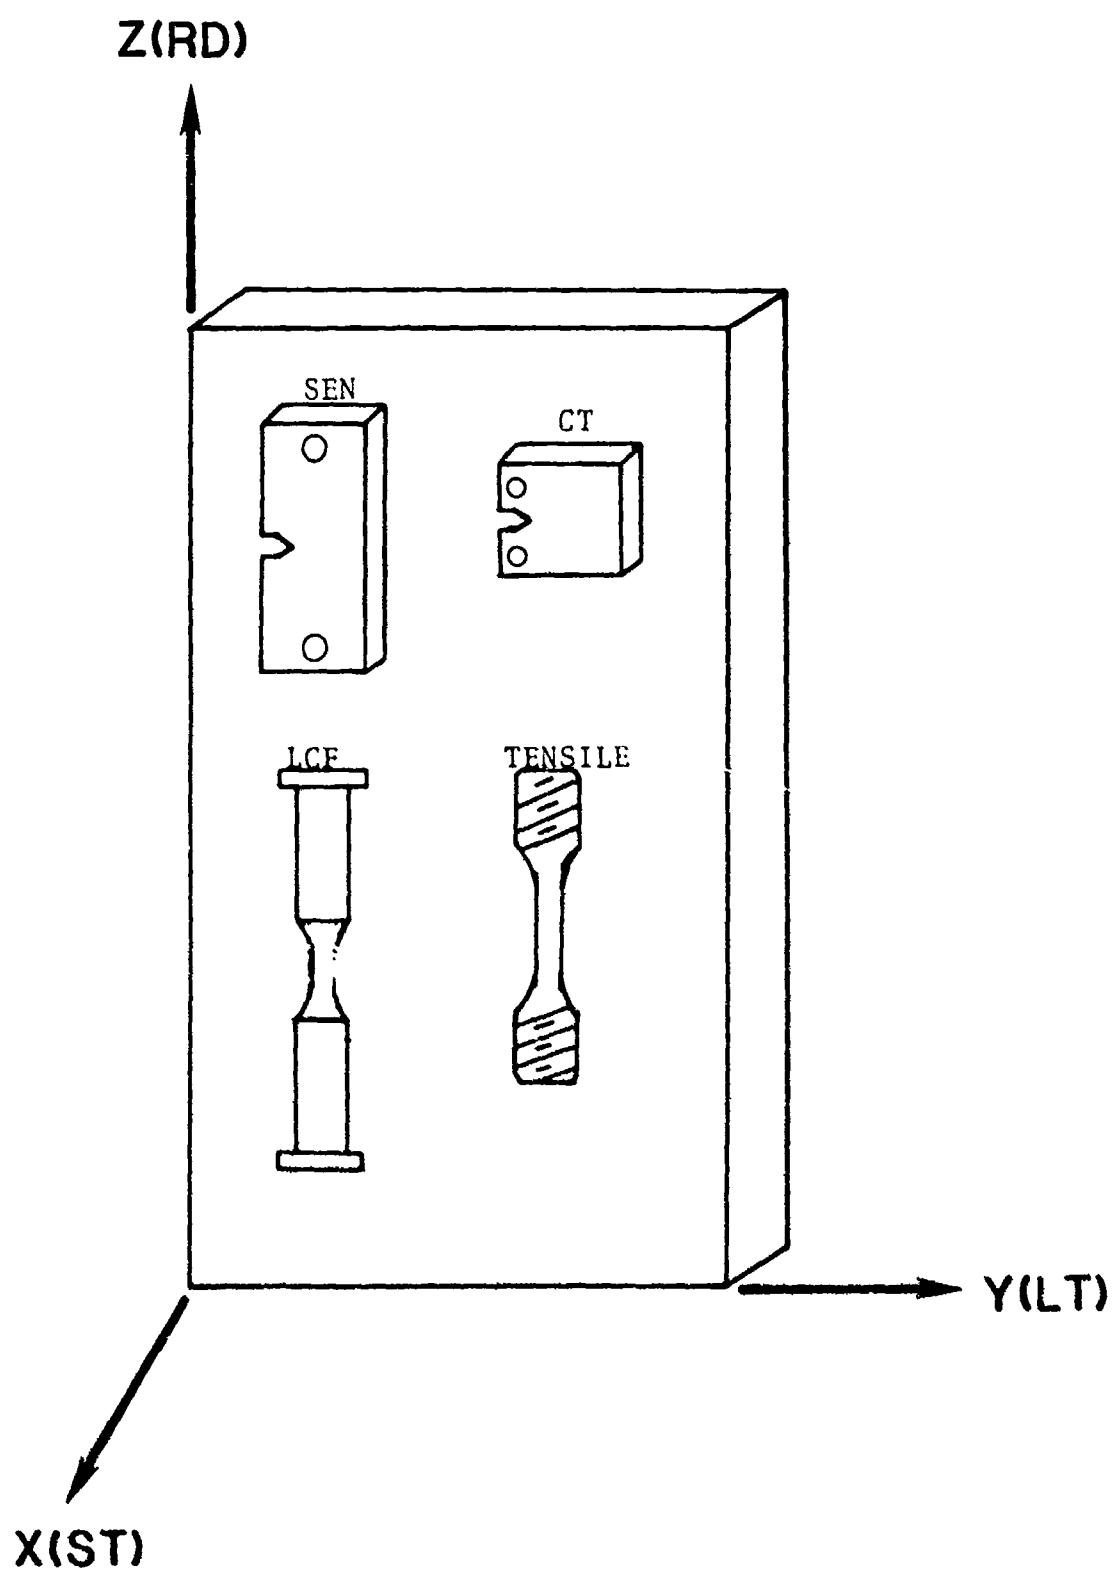
Fig. 1. Specimen configuration relative to the rolling direction of plate.

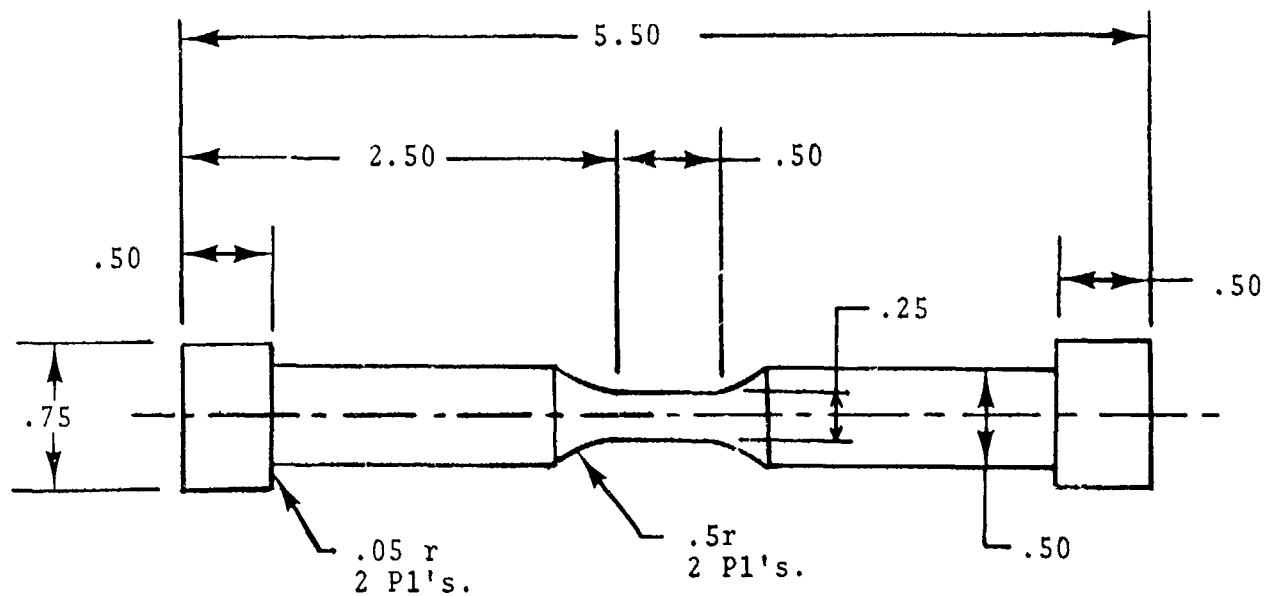
Fig. 3. Smooth bar longitudinal strain control LCF specimen.
All dimensions are in inches.

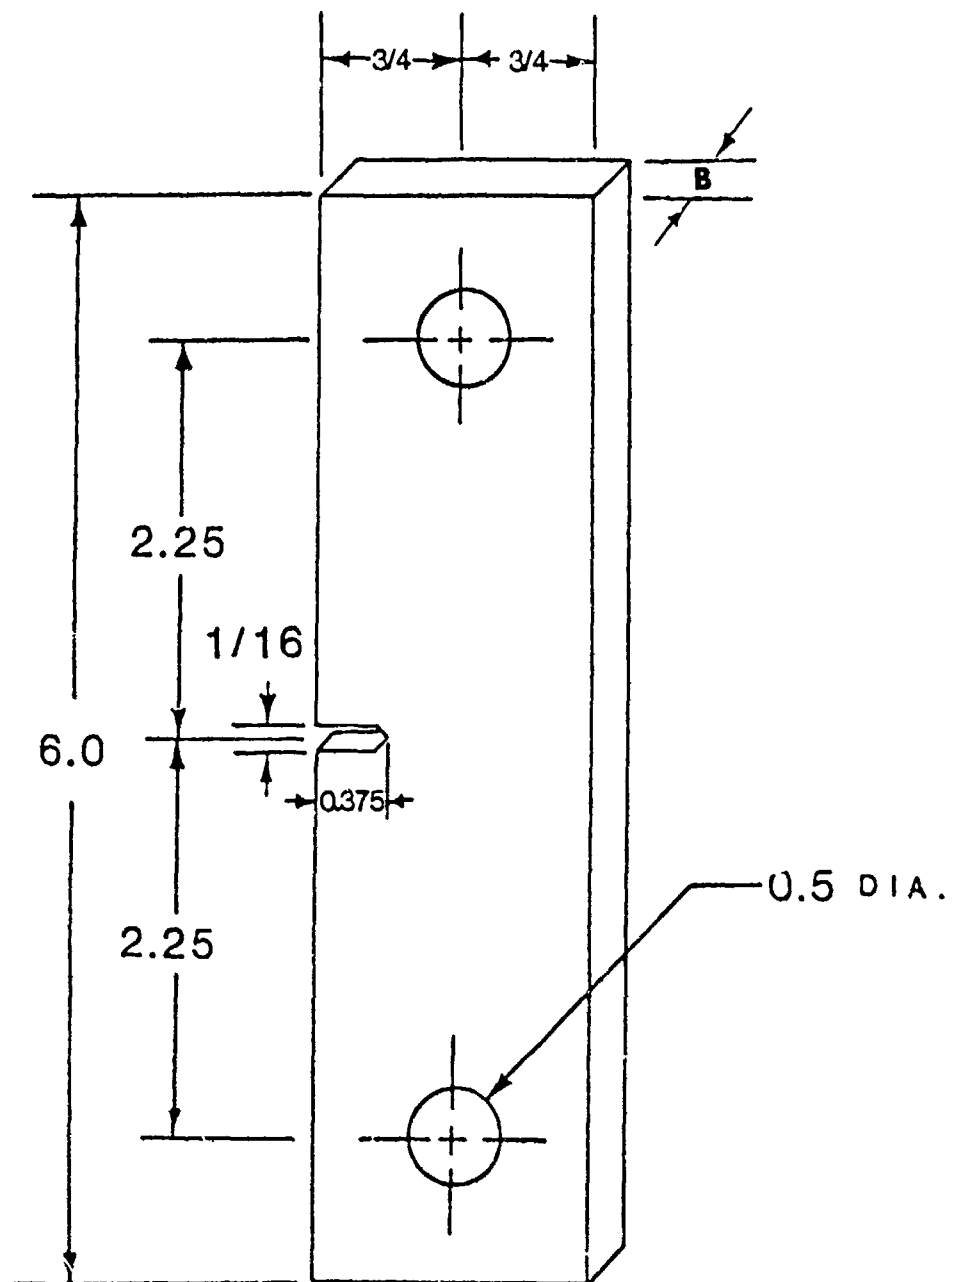
Fig. 4. Single edge notch specimen (SEN).
 (dimensions are in inches)
 Thicknesses of 0.08" and 0.25"
 were used.

Single edge notch (SEN) and Compact Tension (CT) specimens were machined to the dimensions shown in Figs. 4 & 5. The thickness of the SEN specimens was 0.08" and for the compact tension specimens, two thicknesses, 0.25" and 0.5" were used. The faces of the heat-treated specimens were polished to 600 grit and subsequently pre-cracked using a 50 kip MTS machine. Tests were run in the load control mode usually at an R ratio of 0.1 and a frequency of 10 Hz. In some cases the R ratio was varied to study this effect.

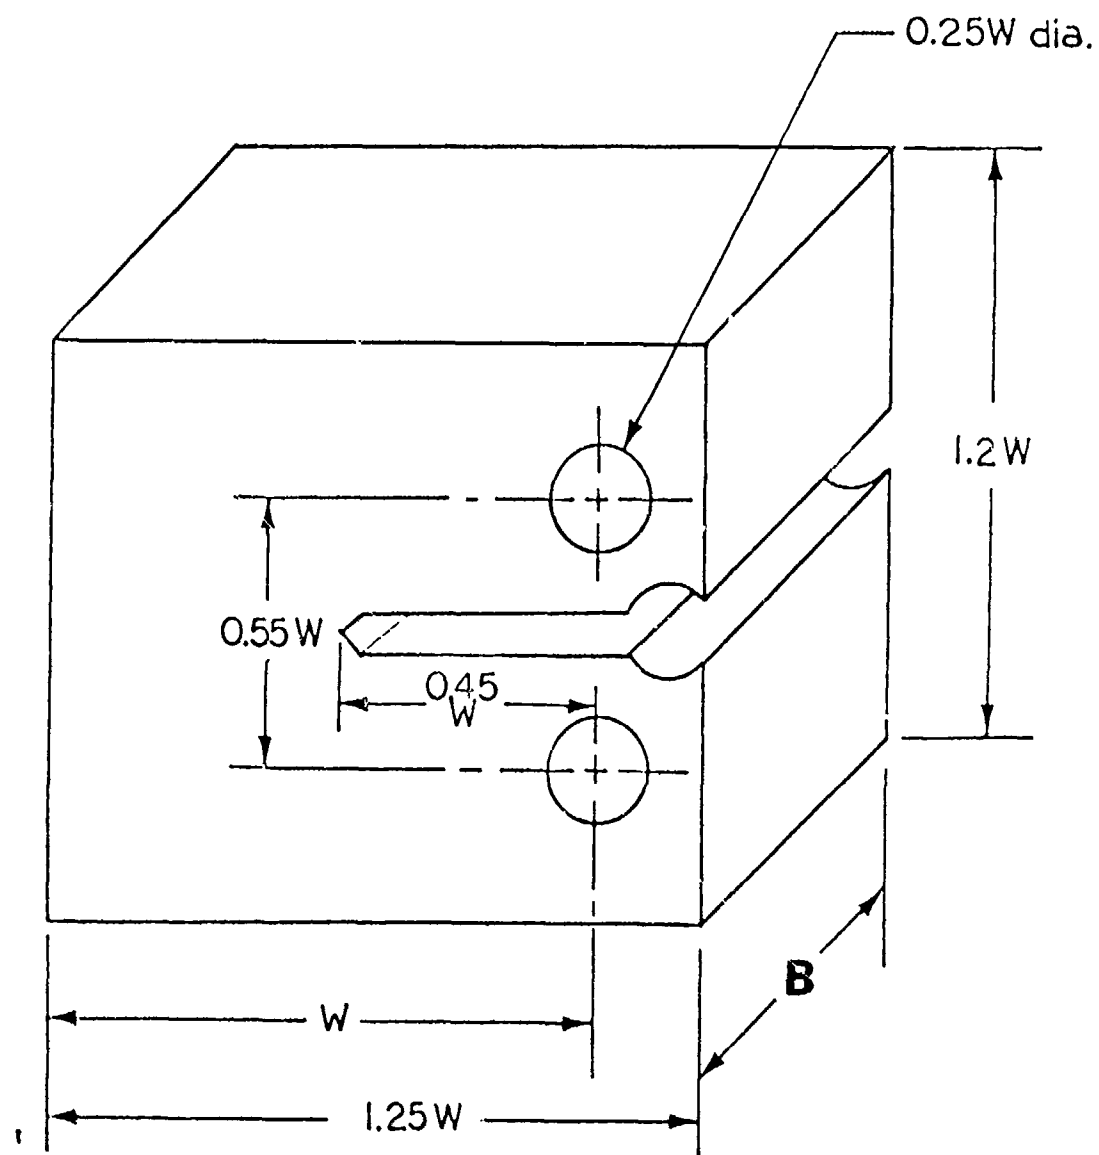
Fig. 5. Standard Compact specimen ($W=1$ inch).
 Thicknesses of 0.25" and 0.5" were used.

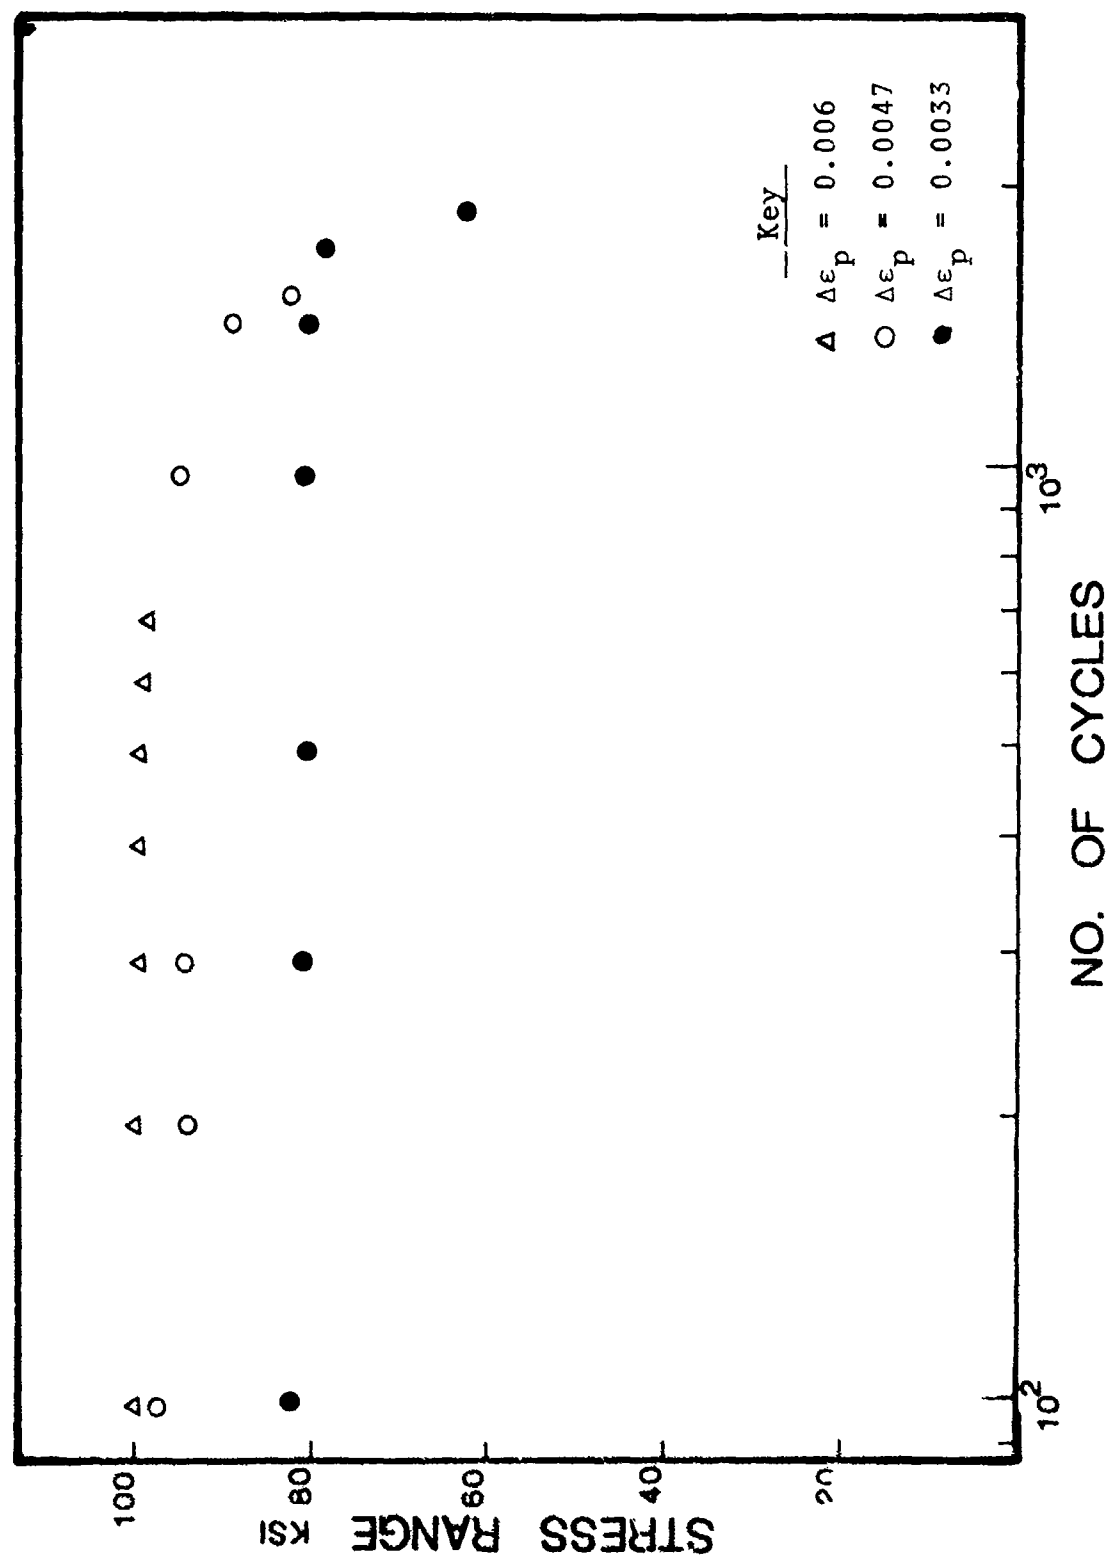
Fig. 7b. Cumulative glide behavior at AF 1410 aged at 950°F for 5 hr.

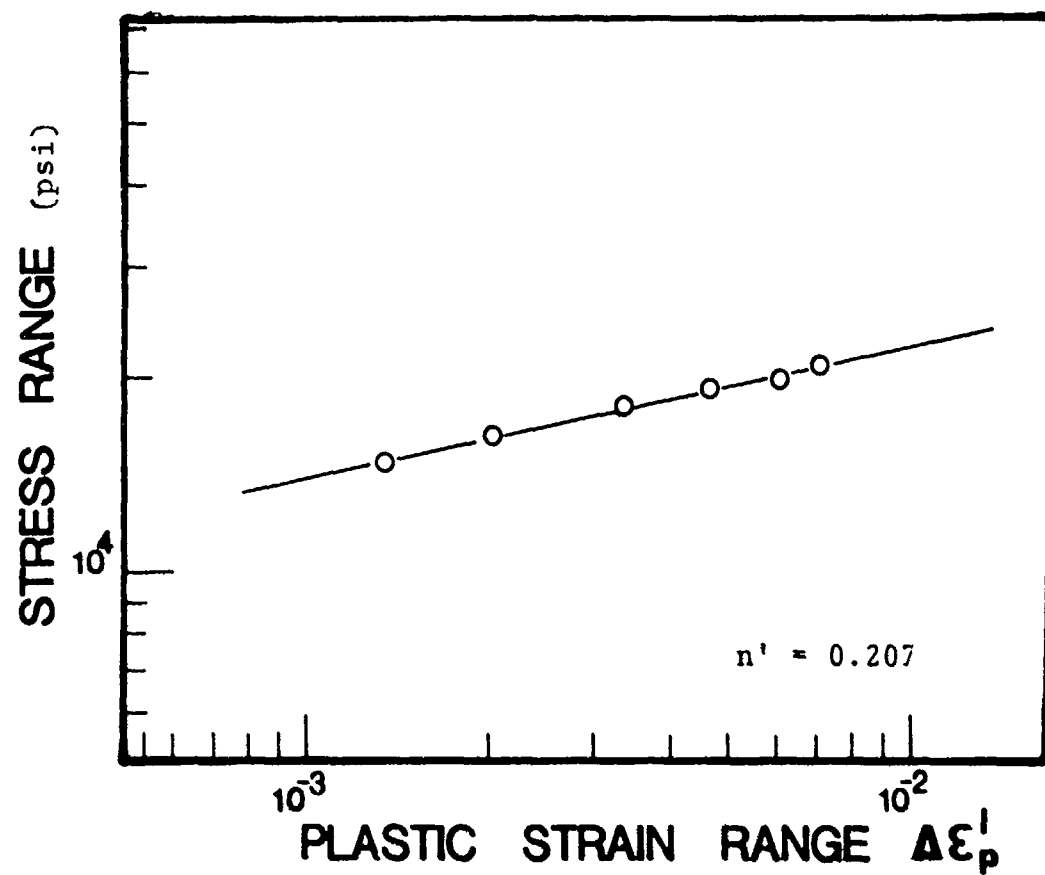
Fig. 8a. Cyclic stress/strain curve of annealed AF 1410.

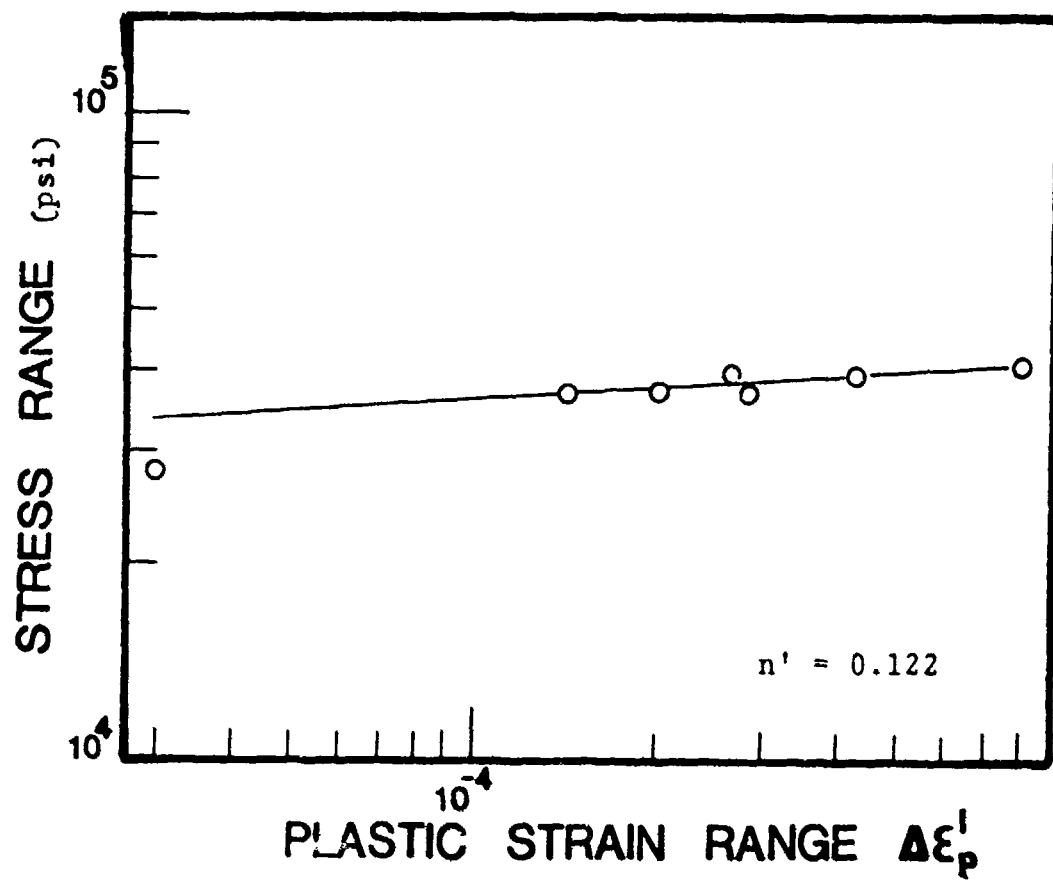
Fig. 8b. Cyclic stress-strain curve for AF 1410 heat treated at 950° for 5 hrs and air cooled.

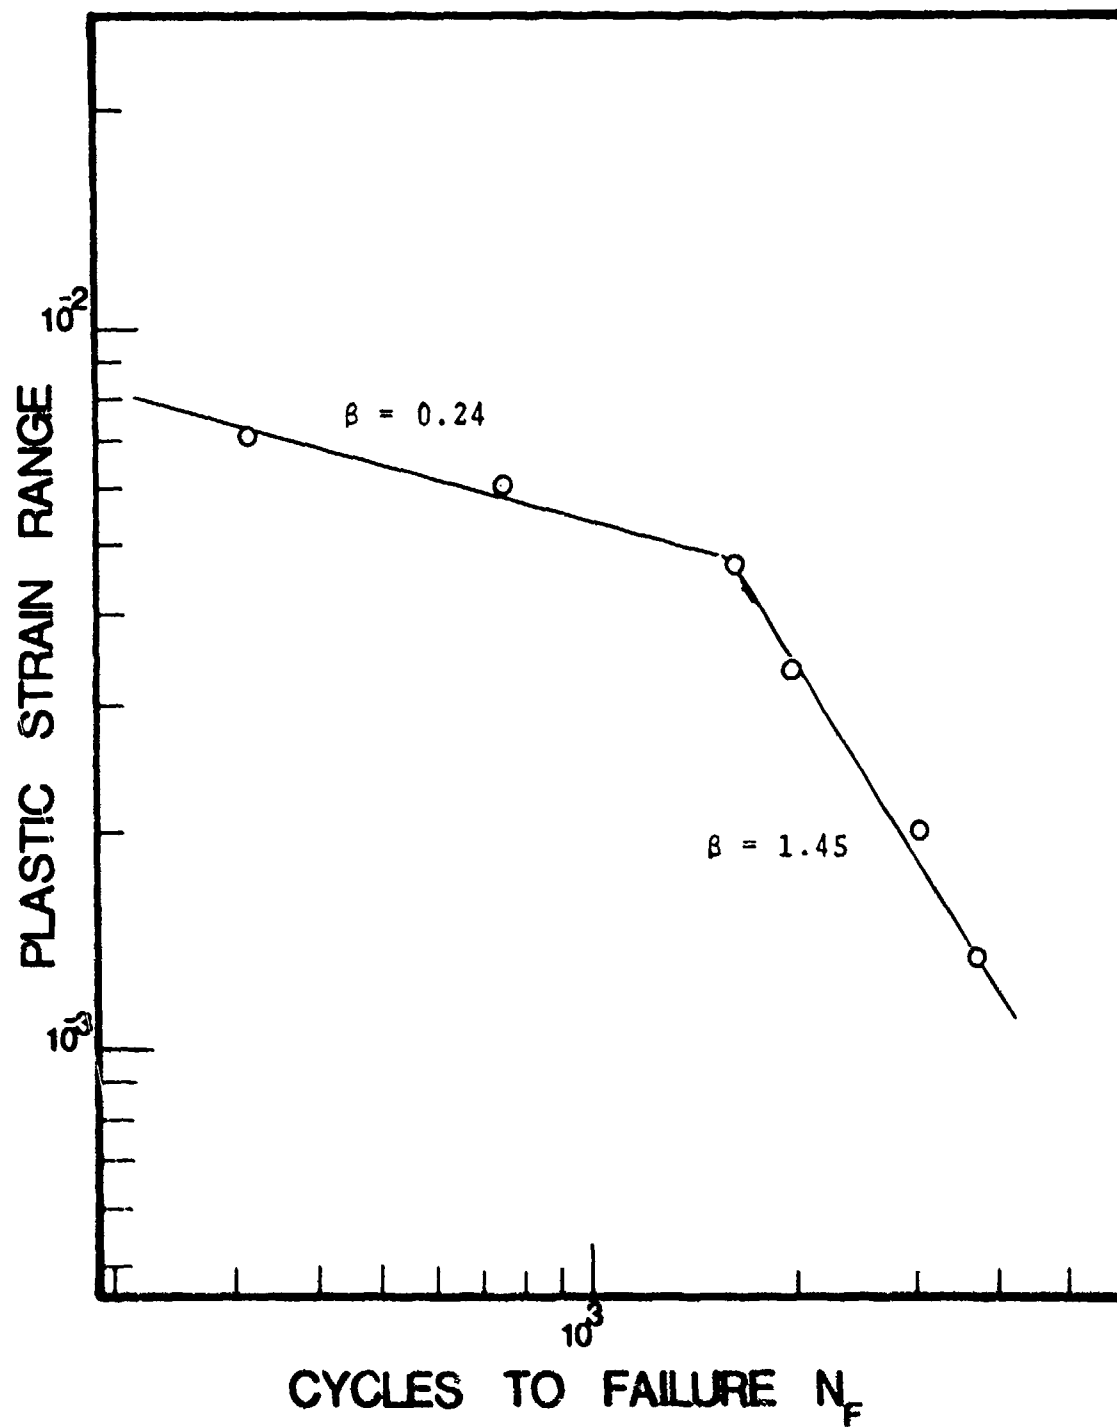
Fig. 9a. Coffin-Manson curve of annealed AF 1410.

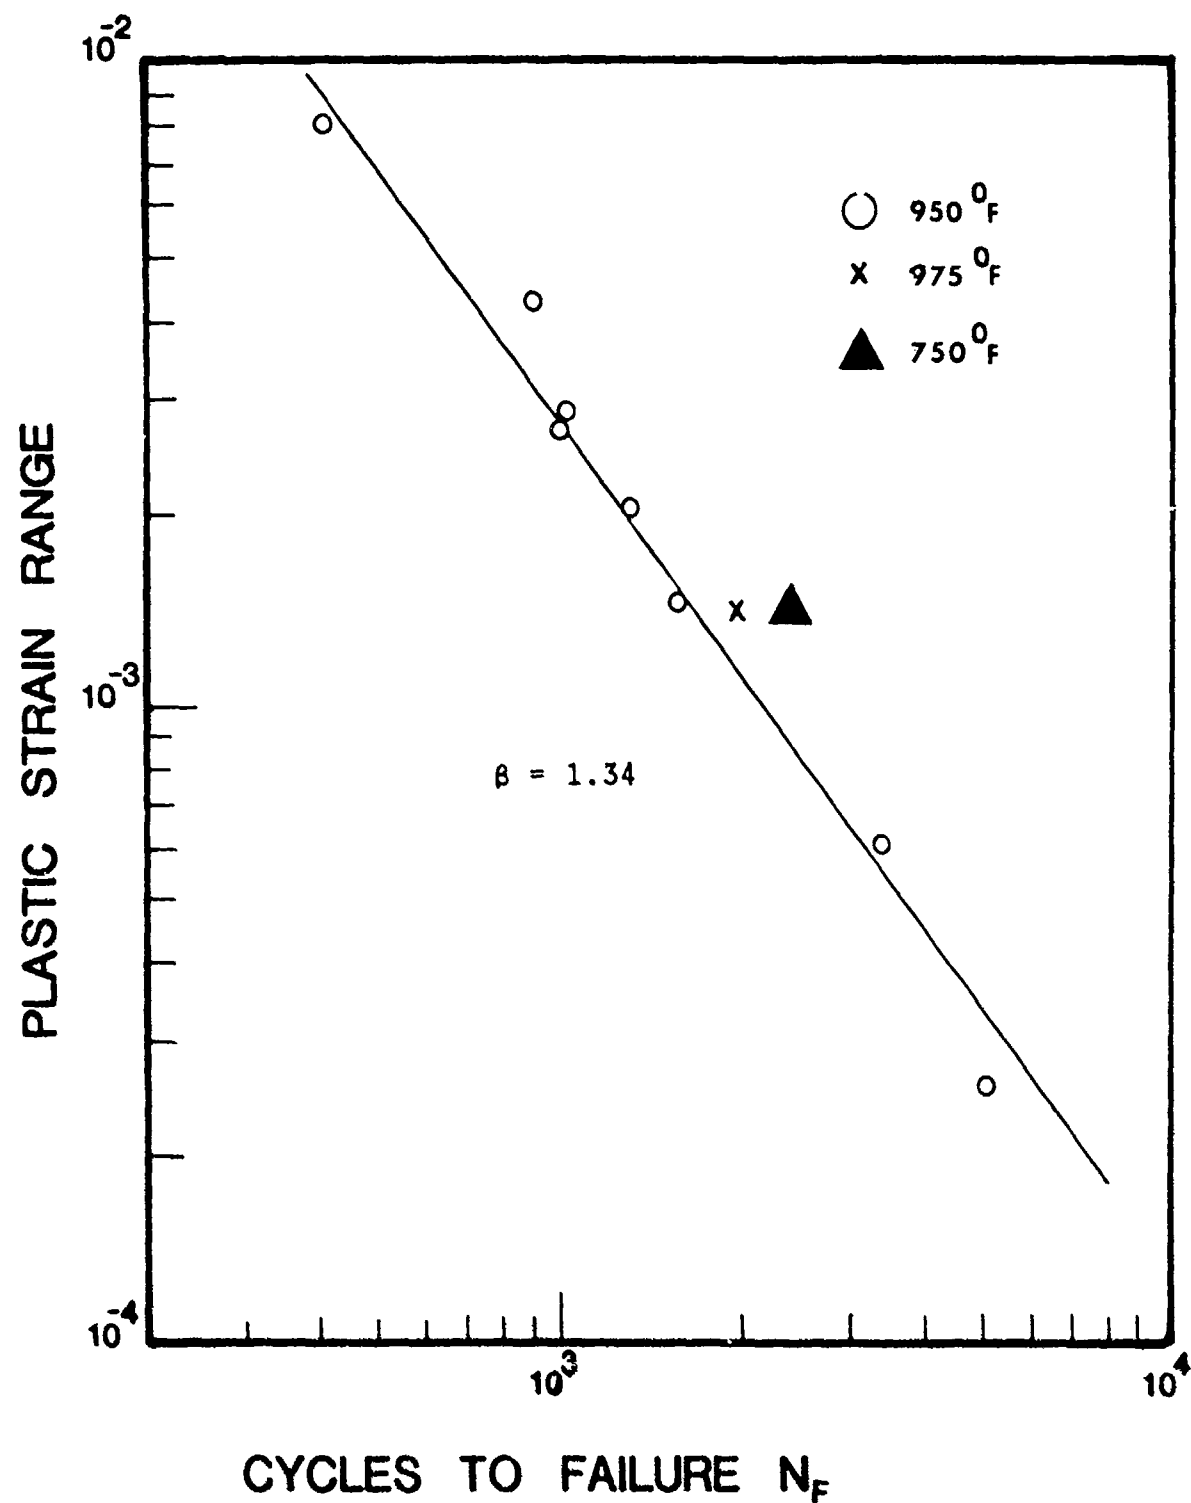
Fig. 9b. Coffin-Manson curve of AF 1410 heat treated at 950° for 5 hrs. air cooled.

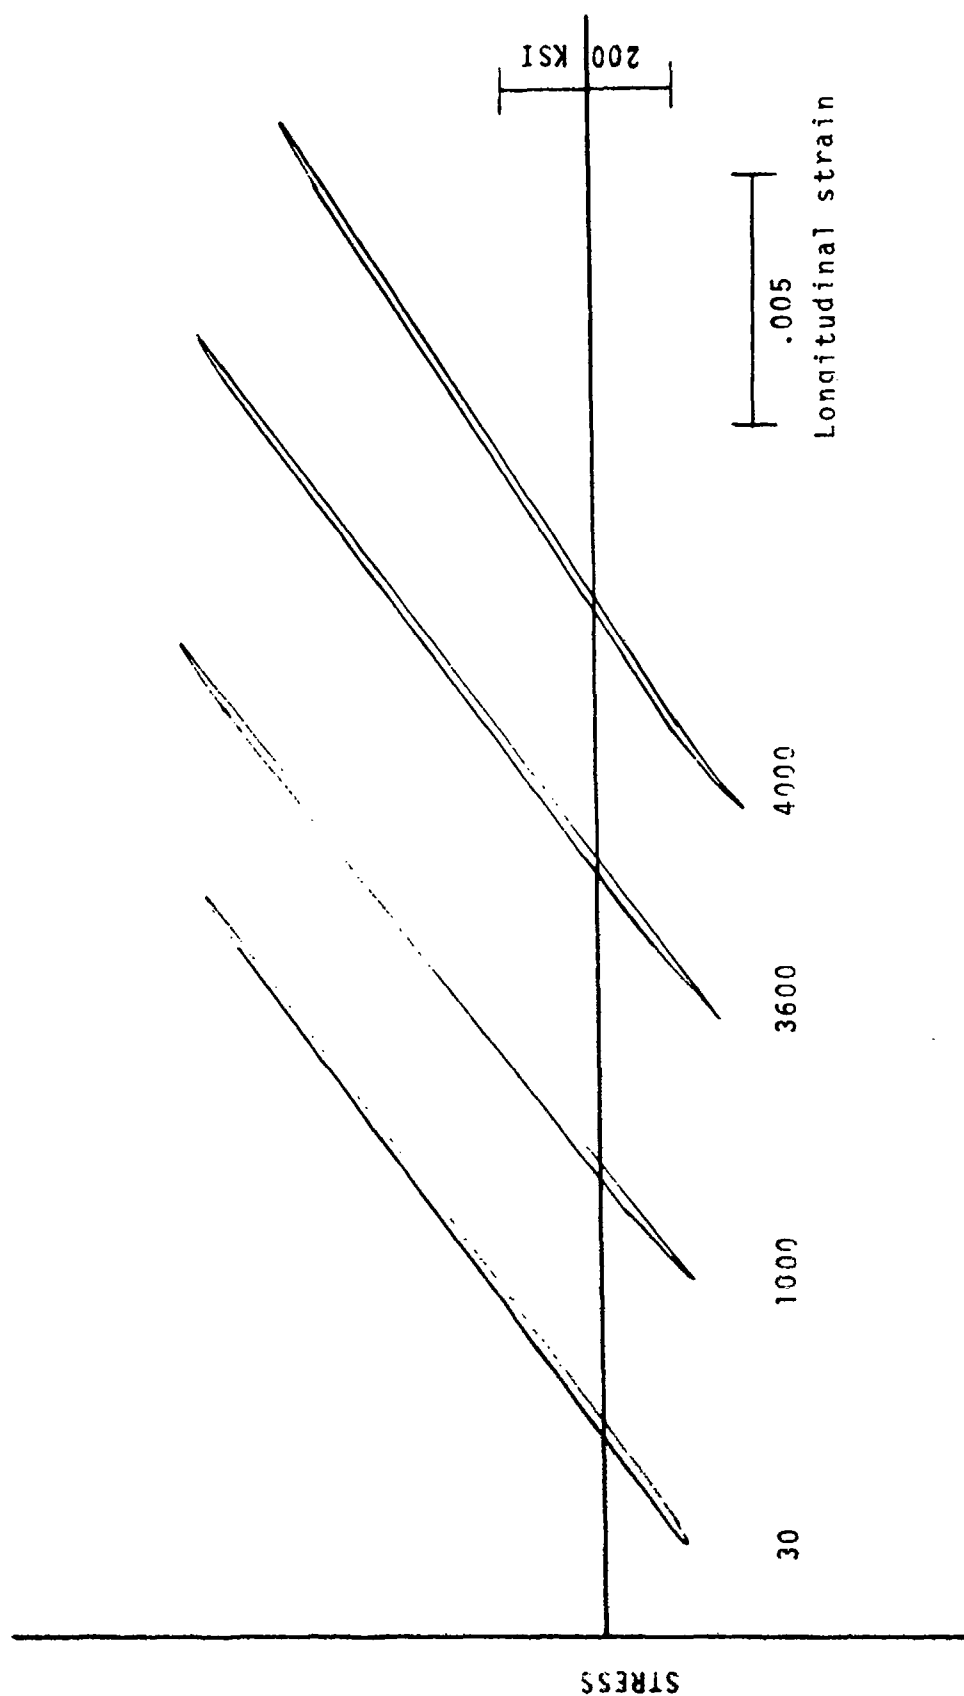
Fig. 10a. Representative hysteresis loops for AF 1410. Aged at 950°F for 5 hrs.
The numbers refer to cycles. $\Delta\epsilon_p^L = 0.29\%$.

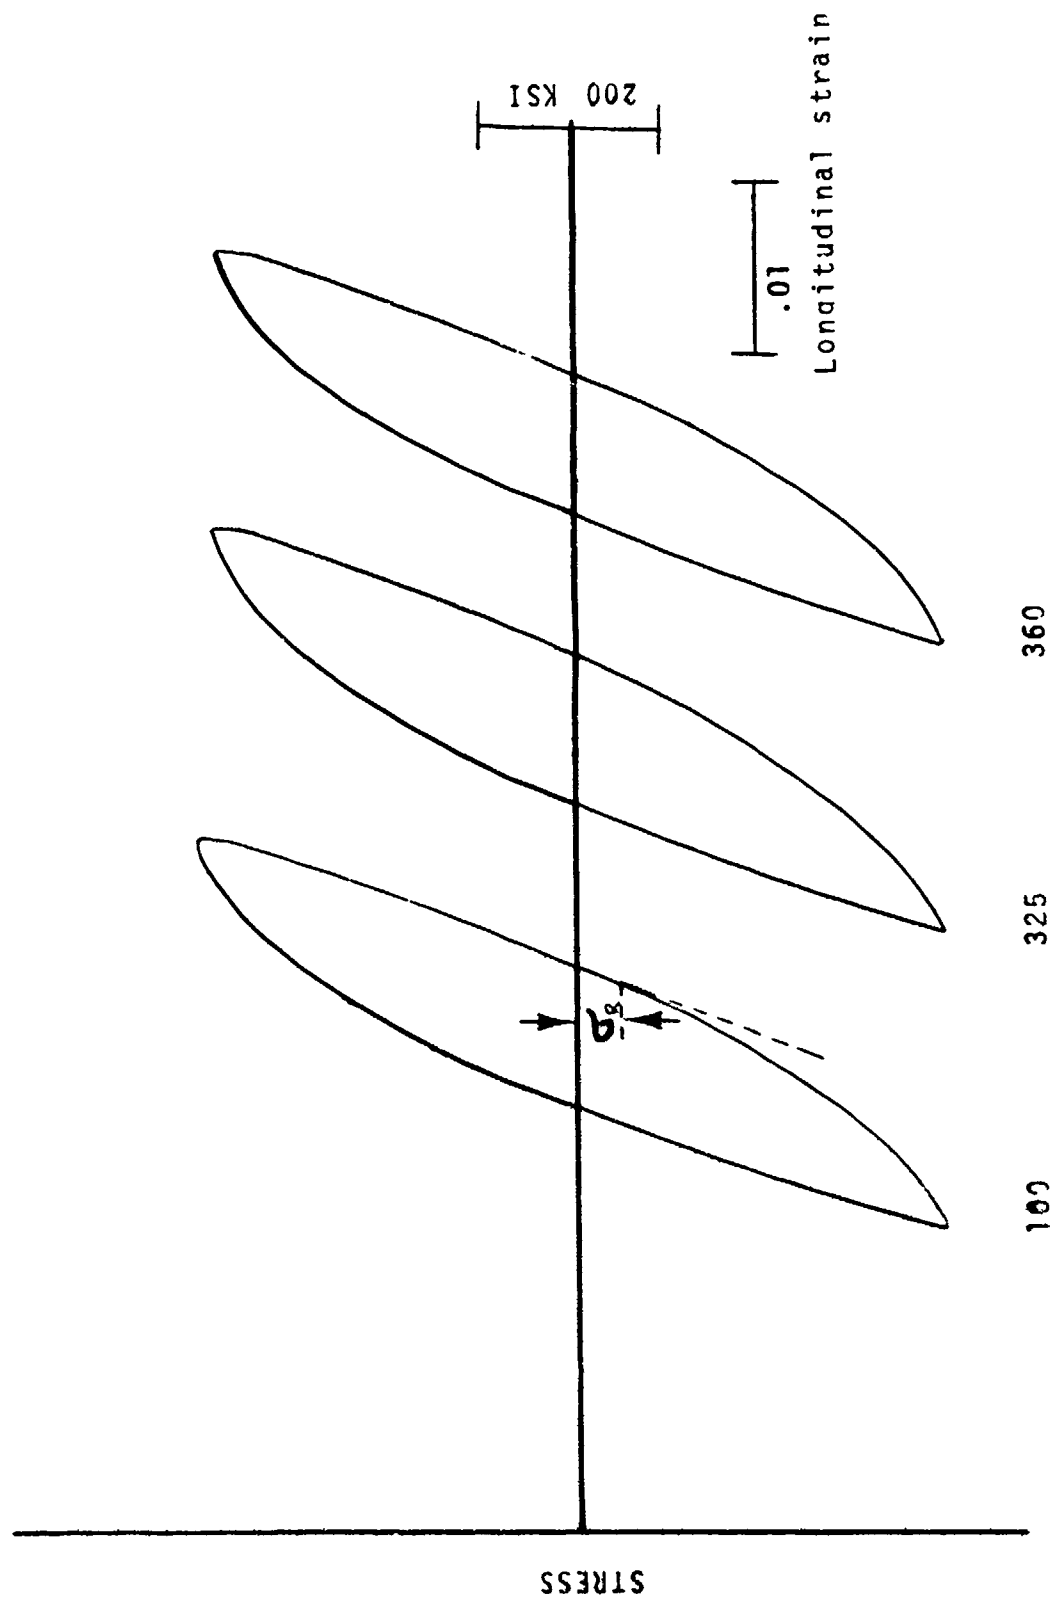
Fig. 10b. Representative hysteresis loops for AF 1410. Aged at 950°F for 5 hrs. The numbers refer to cycles and σ_R is the Bauschinger stress.

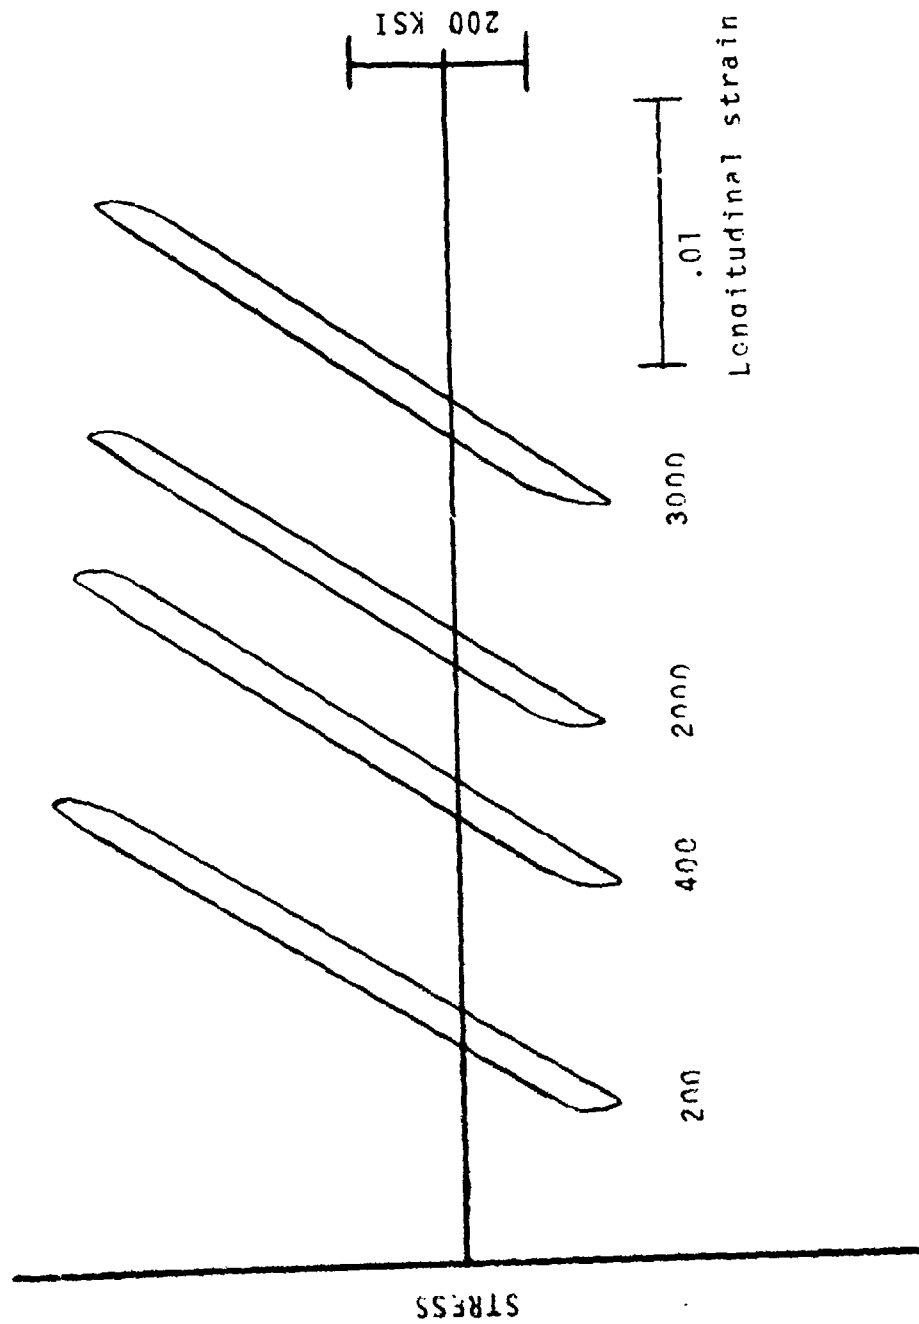
Fig. 10c. Representative Hysteresis loops for AF 1410 in the annealed condition.
The numbers refer to cycles. $\Delta\epsilon_p = 0.134\%$.

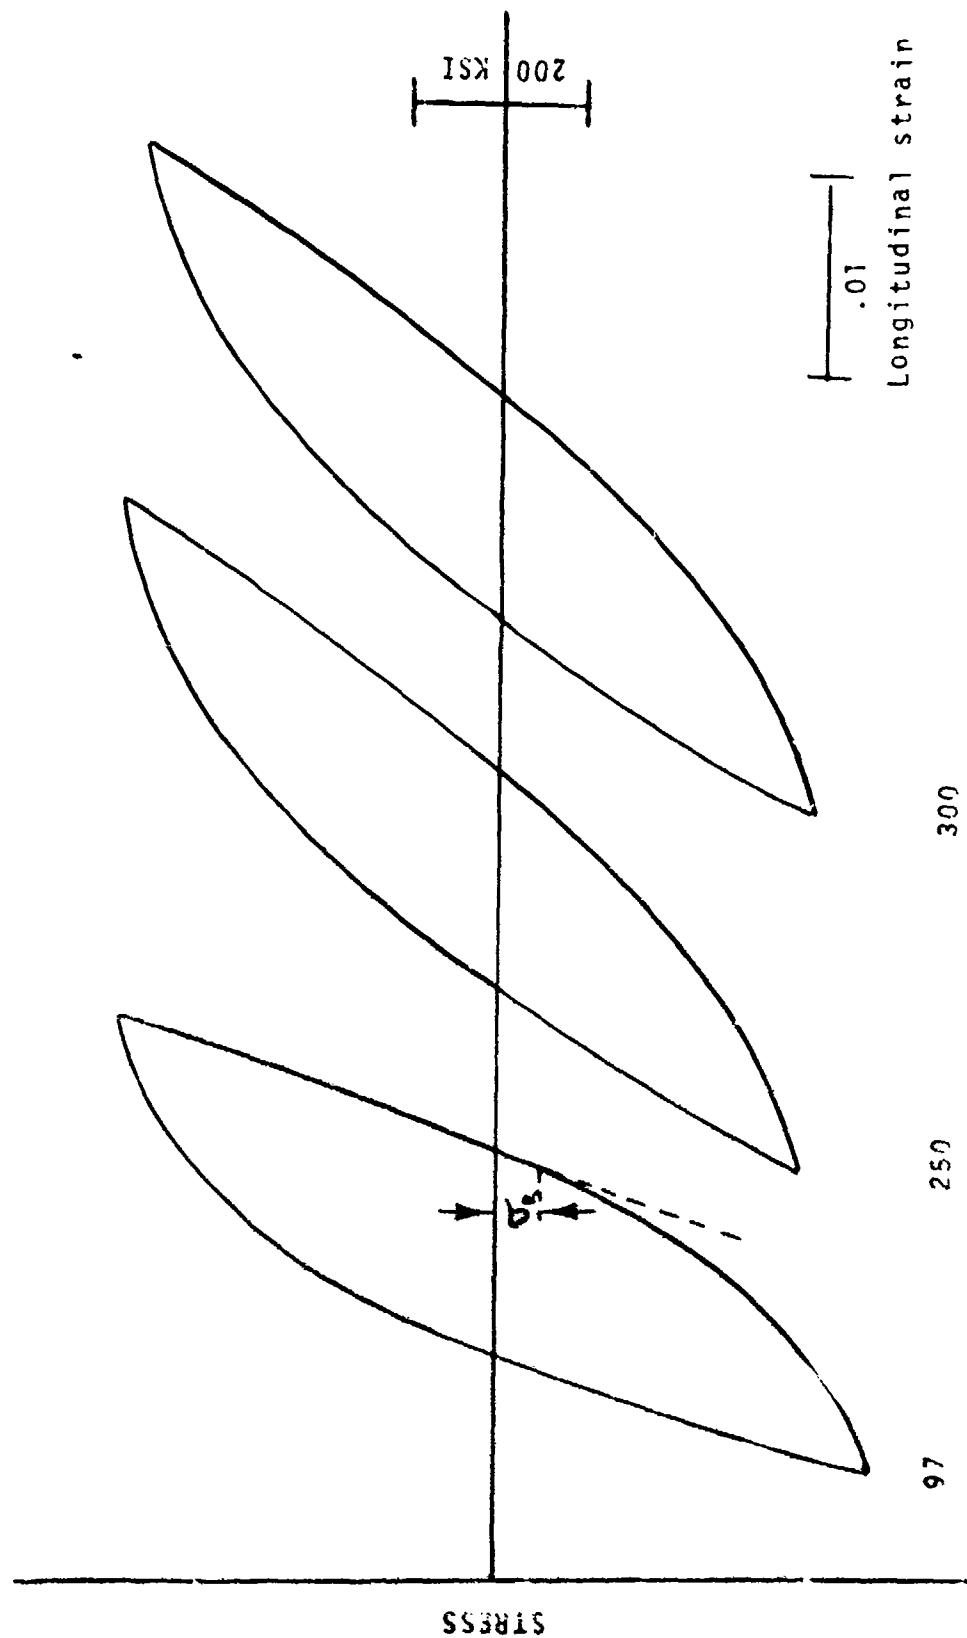
Fig. 10d. Representative hysteresis loops for AF 1410 in the annealed condition. The numbers refer to cycles and the Bauschinger stress is denoted σ_R . $\Delta\epsilon_p^2 = 0.702\%$.

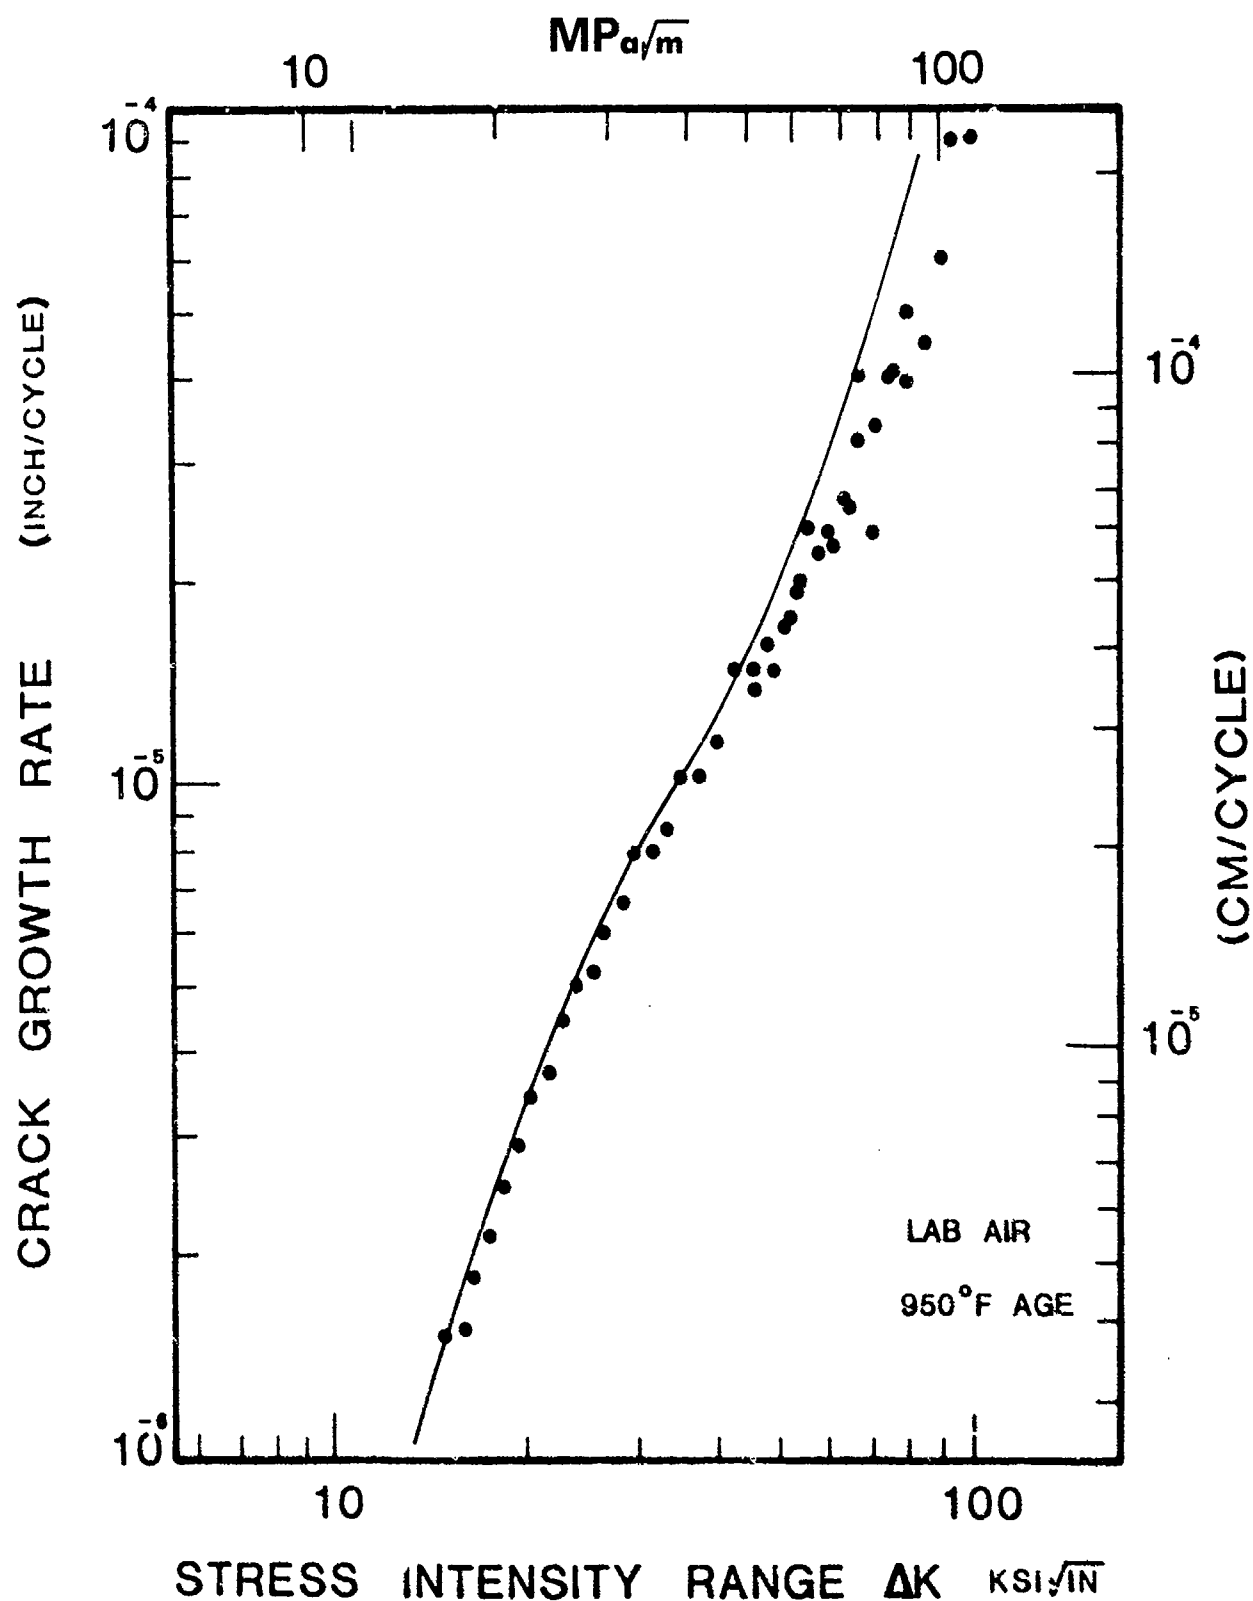
Fig. 11. Fatigue crack growth rate versus stress intensity range for AF 1410 steel aged at 950°F, tested at 10 Hz with $R = 0.1$. SEN specimen, $B = 0.08$ ". Solid line is the data fit in all FCP figures.

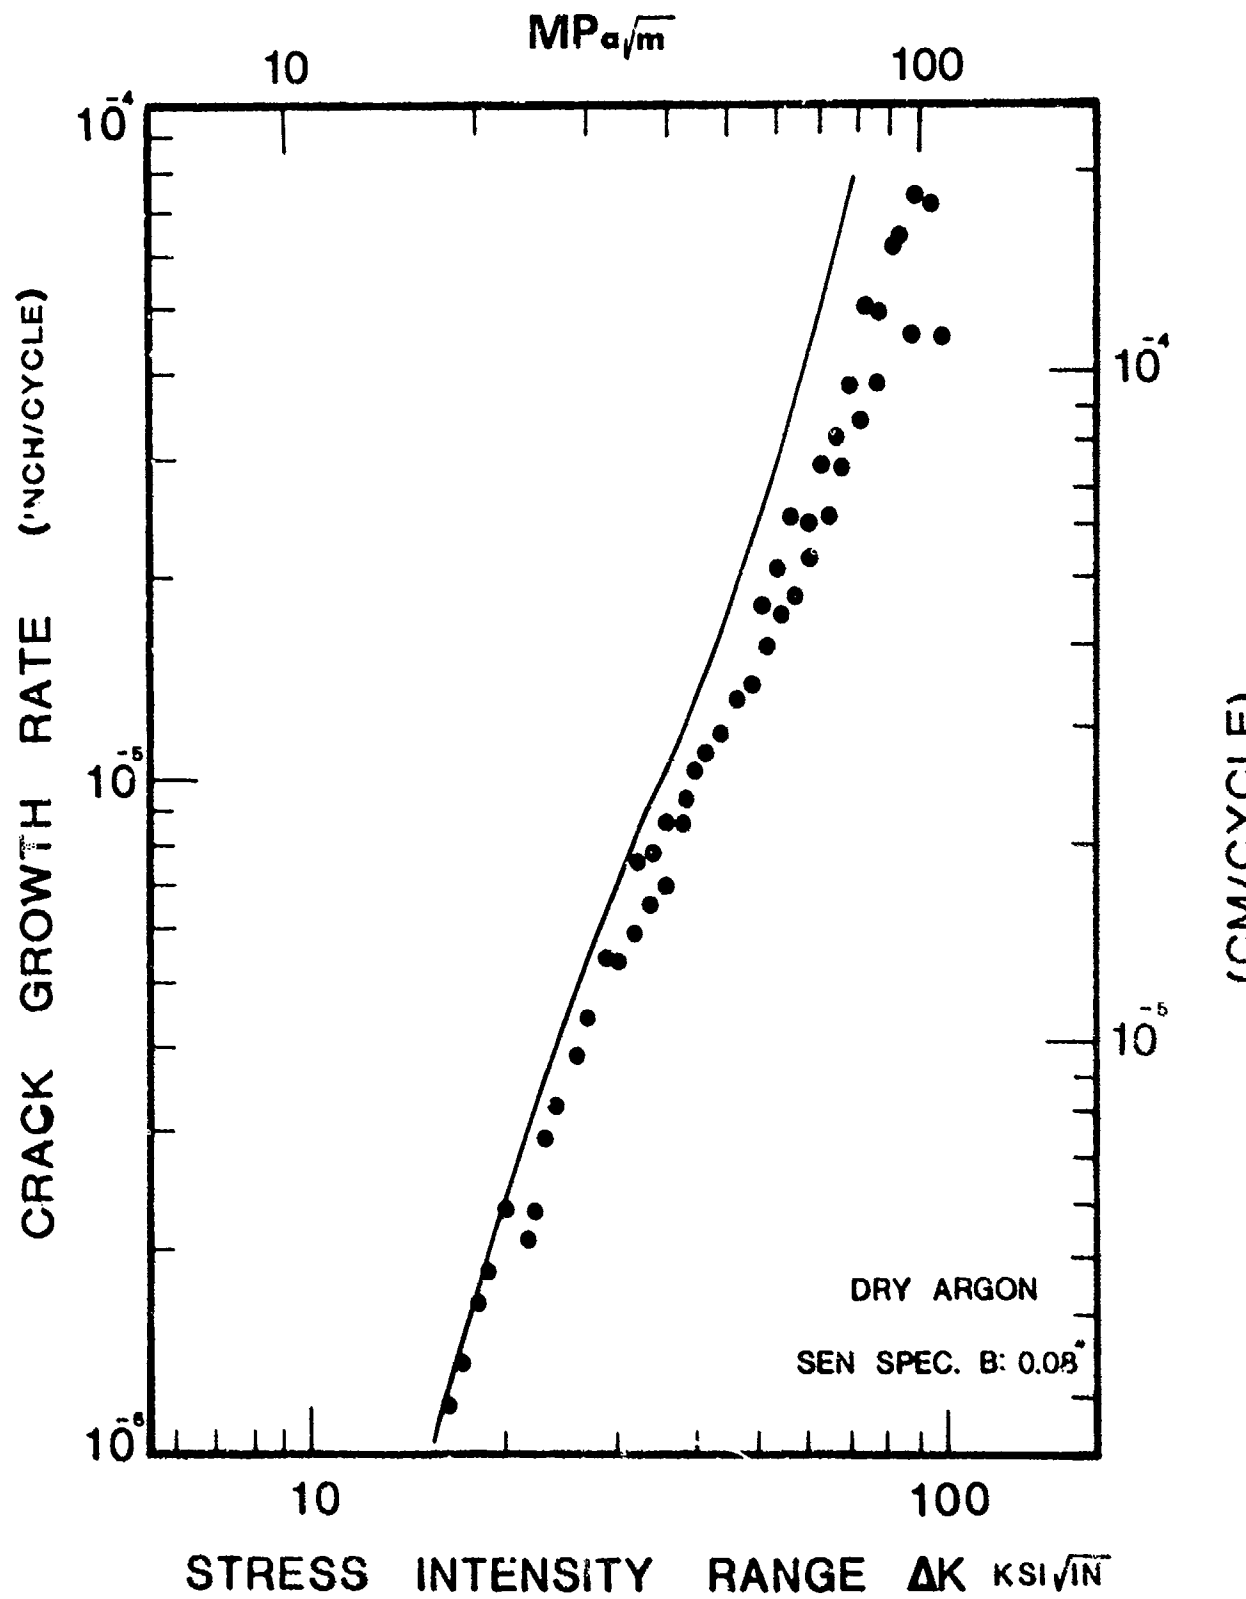
Fig. 12. Fatigue crack growth rate versus stress intensity range for AF 1410 steel, 950°F/5 hrs. age, tested at 10 Hz. and $P = 0.1$.
